*The Waialua Sugar Company
Administration Building*

**Historic
Structure
Report**

FAI Architects | Haleiwa Waialua
Historical Society

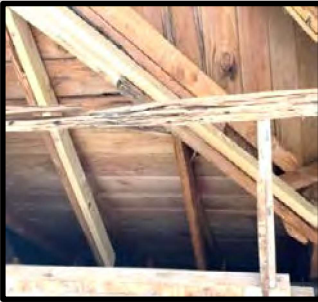
Figure 67: Ceiling studs displays termite damage.

- Consult with a structural engineer as soon as possible. The structural engineer should be able to provide temporary solutions.

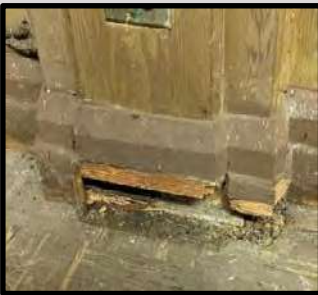
Figure 68: Baseboard exhibits termite damage.

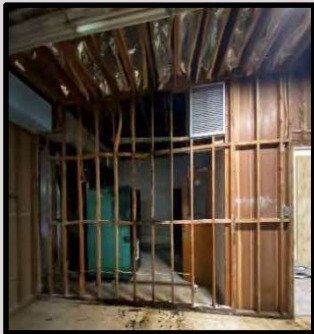
Figure 71: Wood stud framing wall with water damage.

- Consult with a structural engineer as soon as possible. The structural engineer should be able to provide temporary solutions until a more comprehensive plan can be completed.

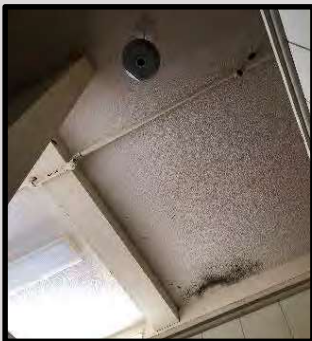
Figure 72: Popcorn ceiling shows mold from water damage.

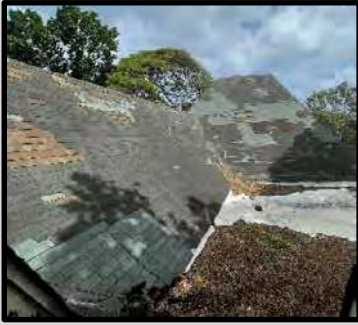
Figure 73: *Roof exhibits sagging and damaged asphalt shingles from water damage.*
Source: *FAI Architects, 2023*

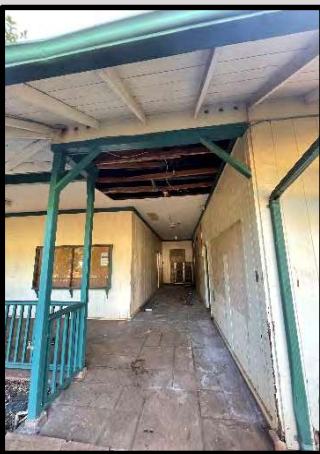
Figure 74: *Supporting wood members exhibits water damage.*
Source: *FAI Architects, 2023*

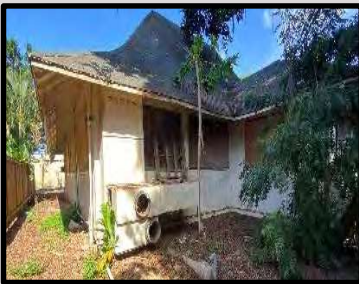
Figure 75: Roof exhibits structural damage.

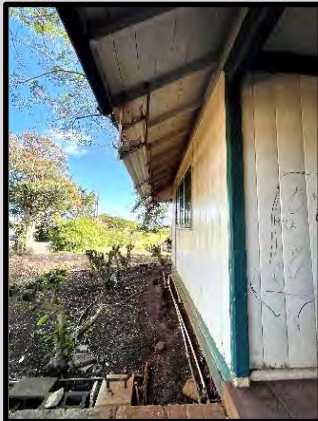
Figure 76: Damaged gutters

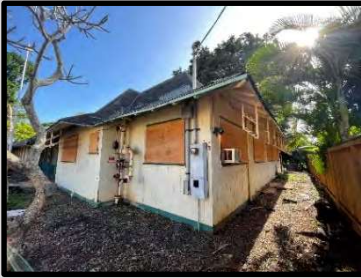
Figure 77: *Boarded up windows with plywood.*

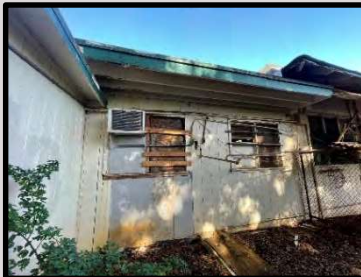
Figure 78: *Deterioration of exterior wood siding.*

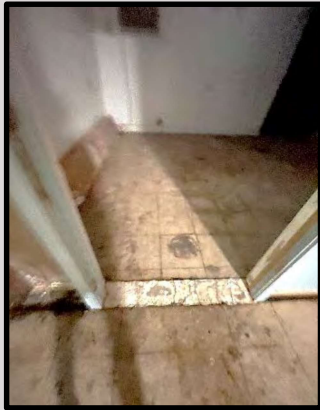
Figure 79: Water damage to VCT tile flooring.
Source: FAI Architects, 2023

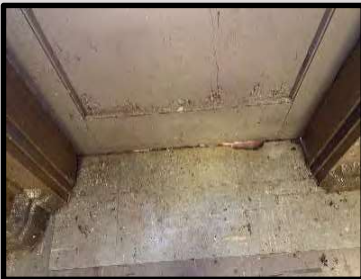
Figure 80: Termite damage to interior door.
Source: FAI Architects, 2023

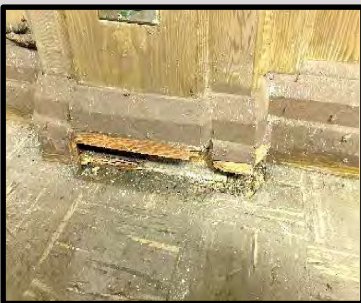
Figure 81: Termite damage to baseboards.
Source: FAI Architects, 2023

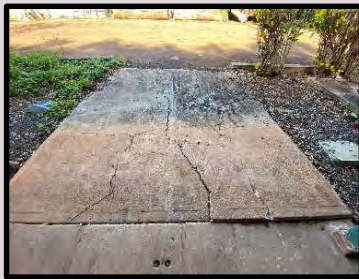
Figure 82 : *Uneven surface*
Source: *FAI Architects, 2023*

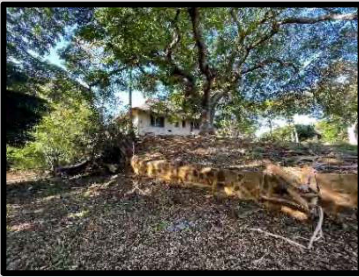
(Figure 86)

Figures 86 & 87: Perimeter foundation/stone retaining wall.
Source: FAI Architects, 2023

- Consult with structural engineer to evaluate foundations.
- Repair or replace in kind.
- Repair fence and secure or rope off uneven/unsafe areas to prevent injury.
