*The Waialua Sugar Company
Administration Building*

**Historic
Structure
Report**

FAI Architects | Haleiwa Waialua
Historical Society

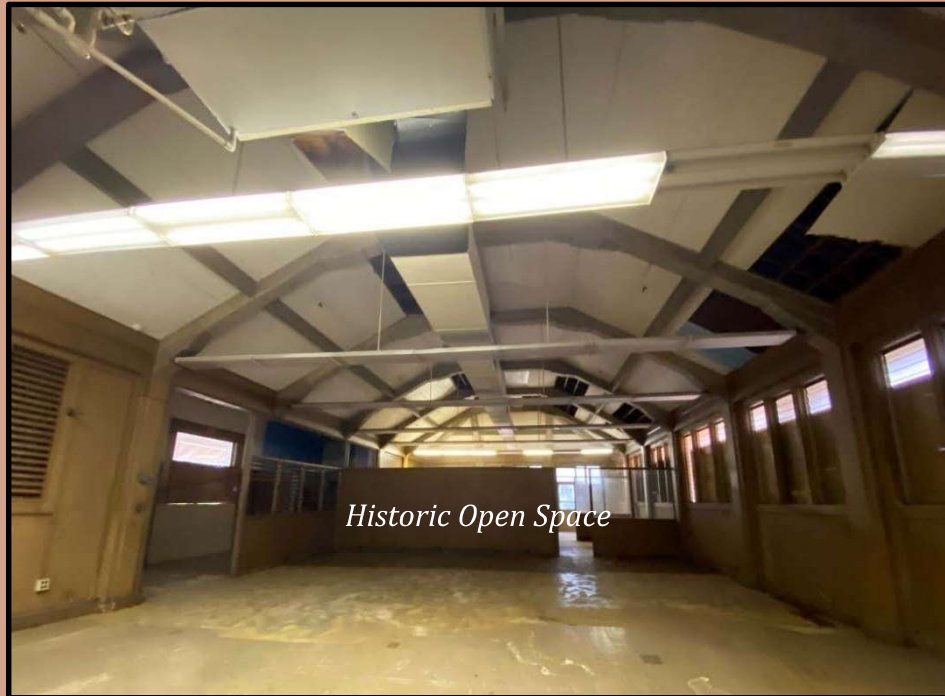
Figure 45: Interior of the accounting office historic open space featuring exposed truss ceiling. Non-original fluorescent lighting.
Source: FAI Architects, 2023

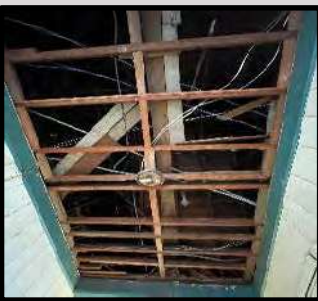
- Exposed electrical wiring in the building needs to be placed into conduits to prevent dangerous risk of electric shock or electrocution.
- For fire and plumbing, the condition and operation of fire sprinklers is undetermined at this time.
- Remove all unused abandoned equipment and replace if needed.

Figure 69: Exposed electrical wires of main entrance ceiling.

- Consult with an electrician to handle, re-route and house exposed wiring properly into conduits.
- Bring plumbing and fire sprinklers up to code and consult with a mechanical engineer for upgrade and full building assessment options.

- Consult with an electrical engineer as soon as possible. The electrical engineer should be able to provide temporary solutions to address hazards until a more comprehensive plan can be completed.

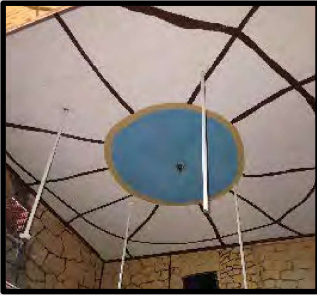
Figure 70: Exposed electrical wires in the FCU office.

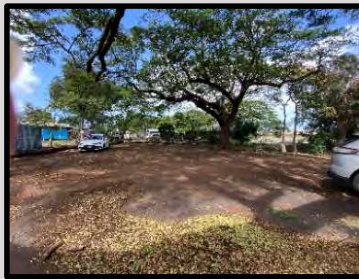
Figure 83: *Unmarked parking and lack of ADA parking.*
Source: *FAI Architects, 2023*

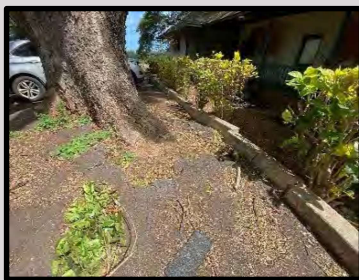
Figure 84: *Tree roots breach through the asphalt pavement.*
Source: *FAI Architects, 2023*

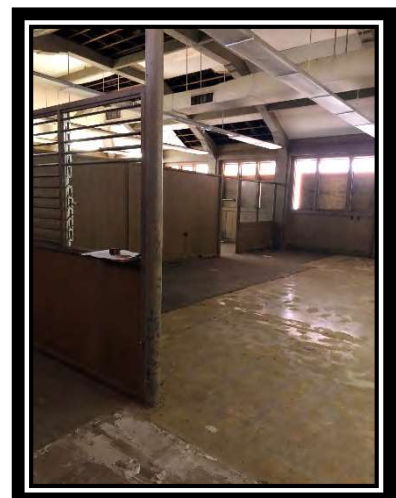
Figure 100: *Wall separating agriculture and accounting*
Source: *FAI Architects, 2023*

9. Remove the added room dividers at the agriculture department, accounting department, and entrance lobby to restore to one large central space.

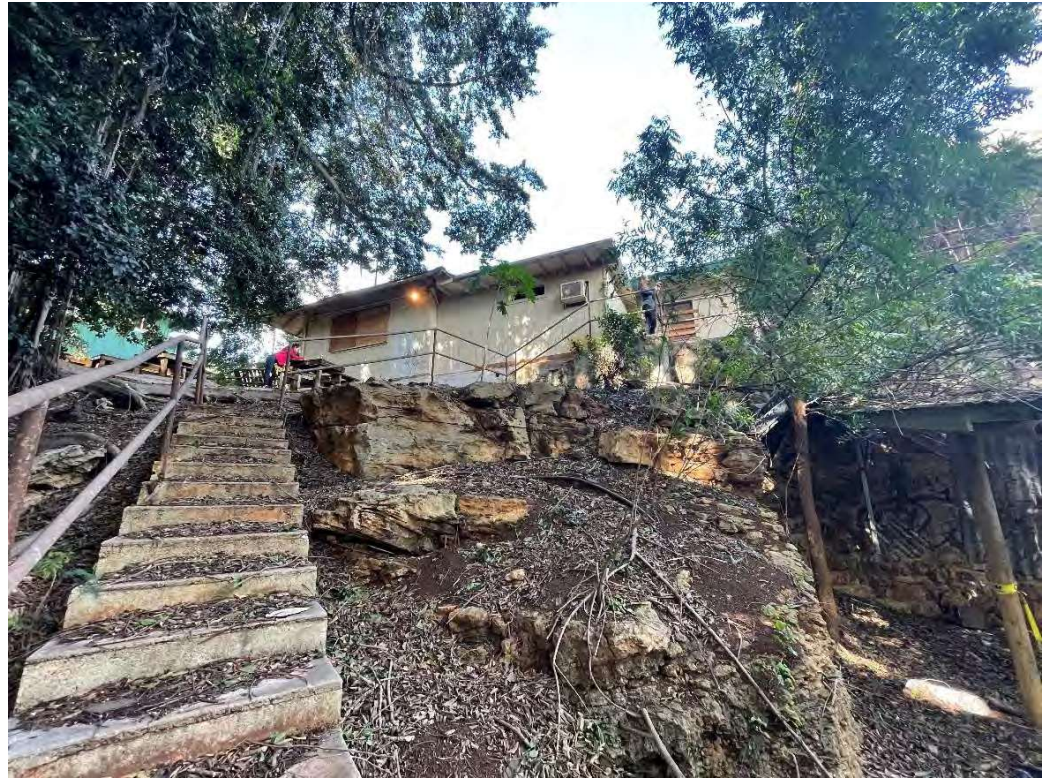
Feature 22, 24, 25

PRIORITY 4: SITE ISSUES				
FEATURES	CONDITION	RECOMMENDATIONS	HISTORICAL RECOMMENDATIONS	PRIORITY LEVEL (Low, Med., High)
22. ADA Accessibility	<ul style="list-style-type: none"> ▪ Uneven surfaces. ▪ Lack of ADA parking. ▪ Lack of ADA restroom and other accommodations. 	<ul style="list-style-type: none"> ▪ Remove mature tree out front. ▪ Add ADA & accessible van parking at main entry at the beginning of the accessible path. ▪ All accessible routes to be 36" wide ▪ Main entrance to be made accessible. <ul style="list-style-type: none"> ▪ Door to be accessible (32" clear width) & push (18") & pull (12") maneuvering clearance ▪ Threshold height, hardware etc. ▪ Accessible signage at door ▪ Accessible toilet is required (either each sex or unisex) (Ch 6) <ul style="list-style-type: none"> ▪ Suggest toilet on the north (left) side of the existing building be expanded to accommodate accessibility ▪ Existing path leading to the restroom is wide enough to accommodate ▪ If adding a water fountain, make accessible. ▪ Accessible signage added throughout to public & permanent rooms. ▪ Protruding objects – no more than 4" protrusion 27"-80" AFF ▪ All switches in public spaces w/a clear floor space (30"x48") positioned at 48" max AFF. 	<ul style="list-style-type: none"> ▪ Re-plant a new tree or trees with a less invasive root system. ▪ Plant large shade trees further away from historic structure. ▪ Consider how ADA and egress code requirements will impact historic character, fabric and space layouts. ▪ Wherever possible, consider first integrating major modifications at secondary entrances/elevations and previously modified spaces rather than original and intact historic spaces. ▪ If a ramp is required, follow ramp height and follow handrail requirements in a historically sensitive manner. 	High (Once use and occupancy needs are determined, as this will help determine the planning needs and removal of mature trees will be easier if it can be done first while site is not being heavily used).

24. Overgrown Vegetation & Mature Trees	<ul style="list-style-type: none"> ▪ Site is overgrown and requires clearing and cleaning. ▪ Banyan tree at south, rear side exhibits aerial roots directly over historic roof and lateral roots encroaching at stairs/building perimeter. 	<ul style="list-style-type: none"> ▪ Consult an arborist and cut back banyan tree. Do not let aerial roots penetrate and damage the roof. ▪ Provide continued trimming and maintenance on a regular basis. 	<ul style="list-style-type: none"> ▪ Consider removing banyan tree if possible. Plant large trees farther away from historic structure. 	High

25. Rear Hillside and Stairs	<ul style="list-style-type: none"> ▪ Significant irregular grade changes at rear of site. ▪ Uneven stairs, multiple locations. 	<ul style="list-style-type: none"> ▪ Complete a topographic survey to establish site boundaries. ▪ Repair stairs and secure or rope off rickety areas to prevent injury. 	<ul style="list-style-type: none"> ▪ Establish more gradual site changes needed for access. 	High

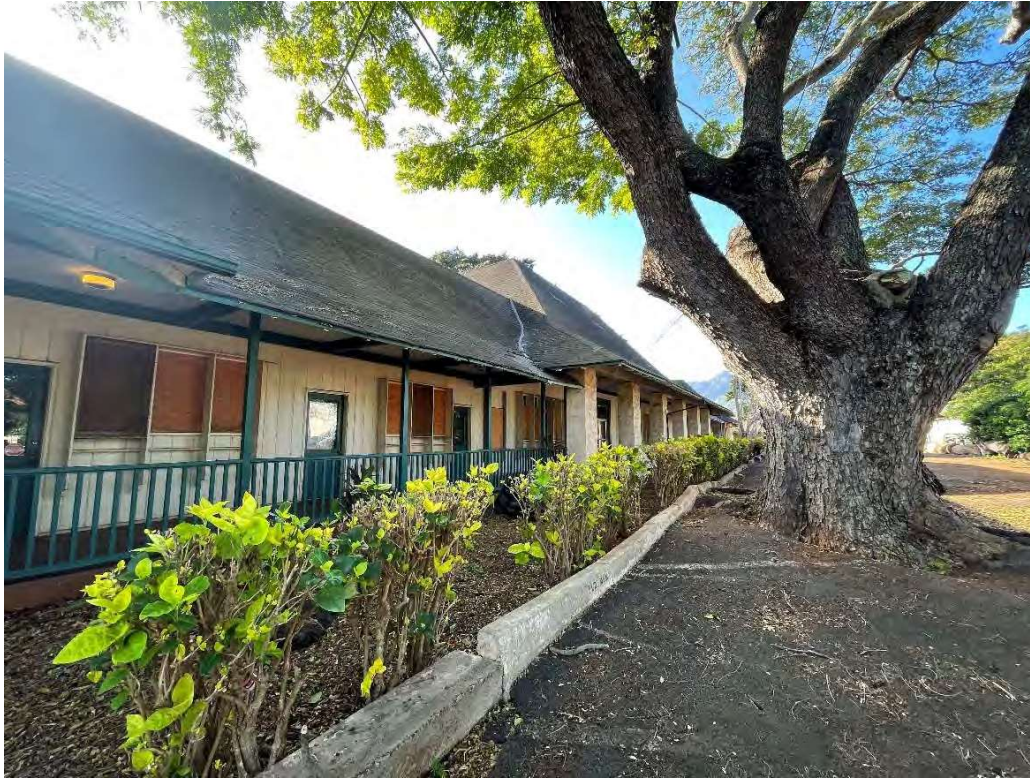
Feature 22, 24, 27

PRIORITY 4: SITE ISSUES				
FEATURES	CONDITION	RECOMMENDATIONS	HISTORICAL RECOMMENDATIONS	PRIORITY LEVEL (Low, Med., High)
27. Parking & Signage	<ul style="list-style-type: none"> ▪ Uneven surfaces. ▪ Striping is very faded and in other areas there appears to be a lack of designated striping. ▪ Abandoned and heavily deteriorated metal carport at rear. 	<ul style="list-style-type: none"> ▪ Re-stripe parking lot. ▪ Add signage (required) to mark ADA parking stalls. ▪ Remove metal carport remnants at rear of site to create a usable parking area or greenspace. 		Medium

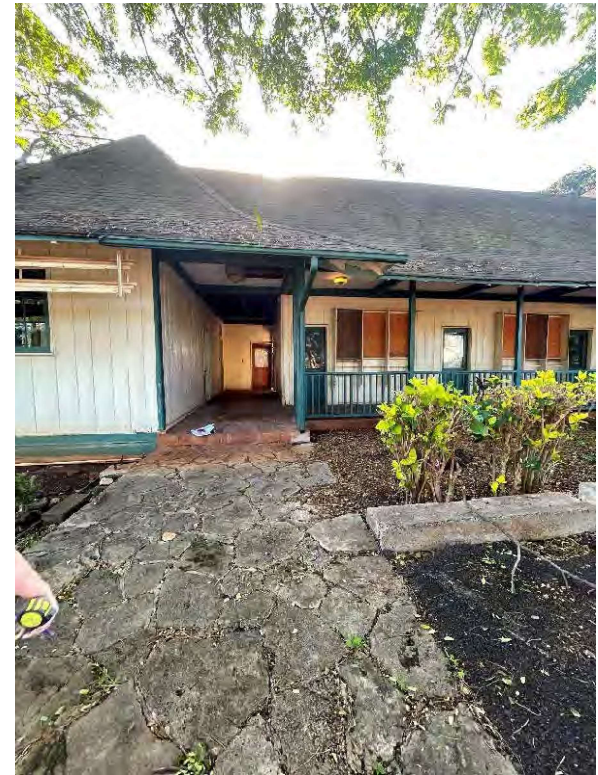
Feature 28

28. Stone walkway	<ul style="list-style-type: none"> ▪ Some of the rough surface, irregular shaped stones at the north, left entrance are damaged, or loose and unsteady. 	<ul style="list-style-type: none"> ▪ Remove pavers and create an even surface for pedestrian and ADA access. 	<ul style="list-style-type: none"> ▪ Remove and reset stone walkway using existing pavers. Replace with similar compatible pavers or cast new ones to match, if possible. (Pending ADA access, if located elsewhere.) 	Low
